This document has been produced by Leadsafe Inspections & Consulting Inc. and is for educational purposes only. For further information, please contact the RI Department of Health at [www.health.ri.gov](http://www.health.ri.gov)

## **Prior to Inspection**

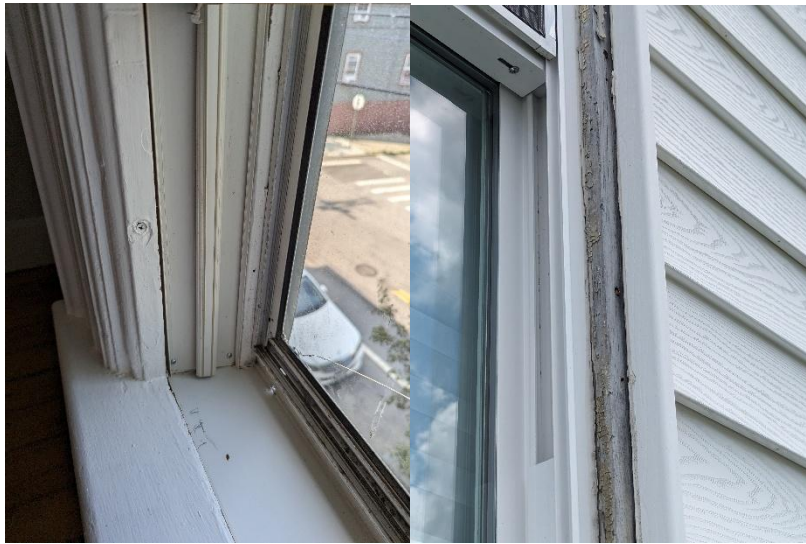
Old wood windows with a wood track are often a lead hazard. We recommend installing vinyl tracks and cover the window well with vinyl flashing or replacing the windows with vinyl. We can come out and test them for you but usually the exterior of the window sash has lead and as it rubs on the track it causes dust

*Window Vinyl Tracks*

*Exterior Window Stop*
